Inspections Complete, LLC

Confidential Home Inspection Report for:

123 Example Lane, St. Louis MO 12345

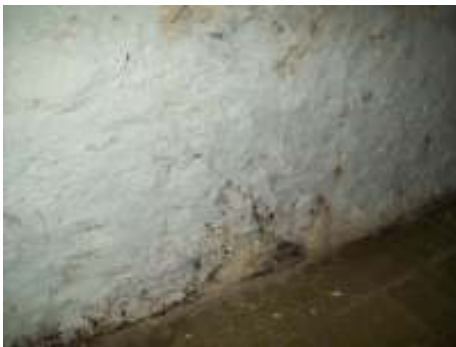
- Moisture stains and efflorescence (The white calcium or mineral deposits that are left when water evaporates) were noted on the interior of the southwest foundation wall. These stains showed some moisture when tested with a moisture meter. Moisture is not unusual for a stone foundation but the client may wish to have an evaluation by a qualified foundation contractor to determine if drain tiles are needed after the downspouts are properly connected and the landscaping is tapered away from the house.

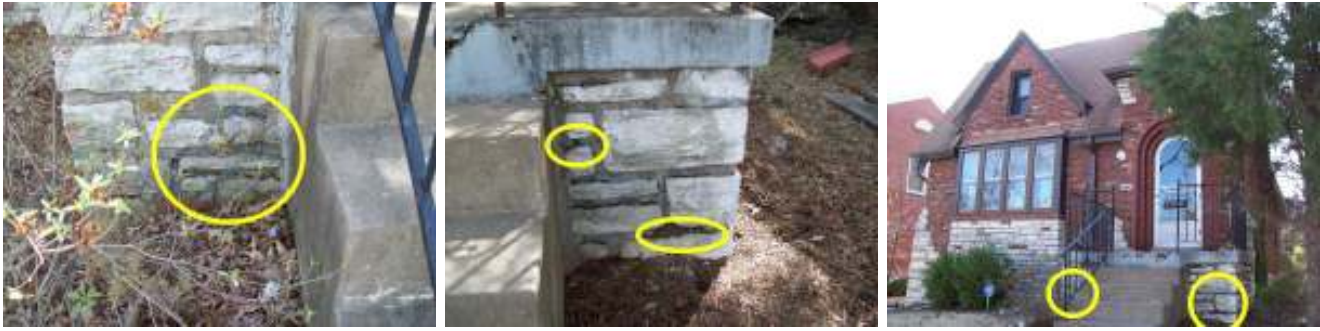
- Moisture stains and efflorescence (The white calcium or mineral deposits that are left when water evaporates) were noted on the interior of the room under the front porch. The moisture is likely entering through the voids in the stone around the porch. The stone needs to be tuck pointed to discourage moisture from collecting in the openings.

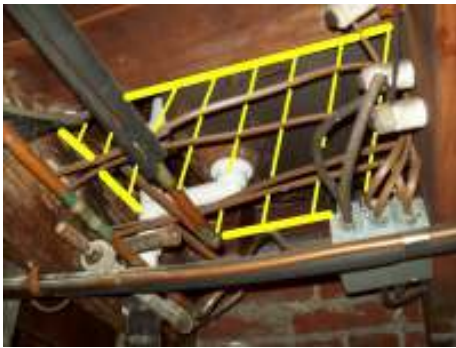
- SAFETY CONCERN - An opening was noted below the bathtub drain where it passes through the sub floor. This could allow the spread of fire to the upper floors. A fire stop (1/2" drywall, 3/4" plywood, or 22 gauge metal) should be installed.

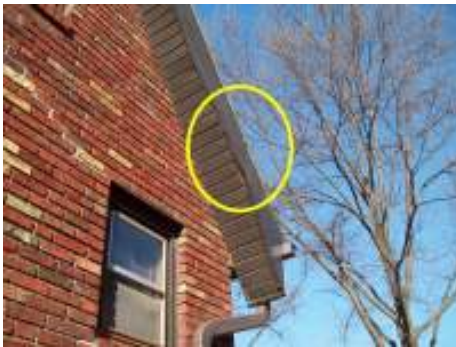
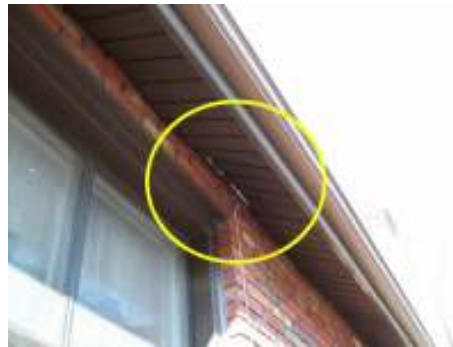
- The brick walls are in serviceable condition. Tuck pointing may be necessary as a part of ongoing homeowner maintenance with an older brick home.
- The exterior trim is in serviceable condition.
- The fascia and soffit covering near the north corner and near the east corner is loose or damaged and needs to be repaired.

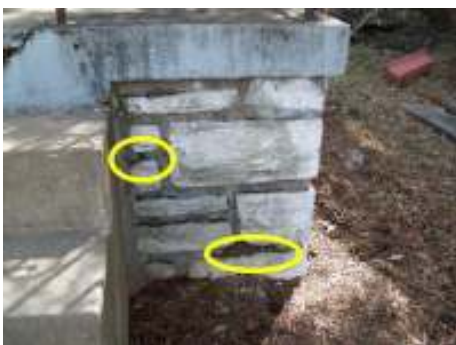
- MAINTENANCE TIP: The exterior windows, doors, and trim should be kept sealed to prevent moisture intrusion.
- The stone around the front porch needs to be tuck pointed.

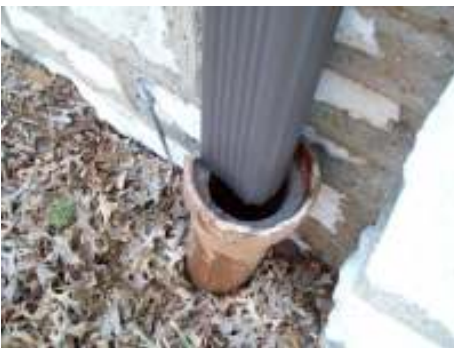
- **MAINTENANCE TIP** - The gutters are mostly covered with screens. The gutters will still need to be maintained on a frequent basis to prevent debris buildup and gutter overflow; which could damage the exterior components and allow moisture intrusion into the basement.
- The northeast downspout does not align with the underground drain and needs to be adjusted.

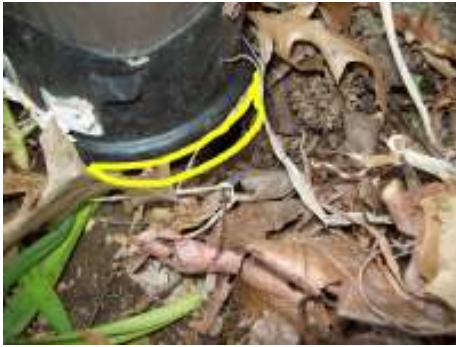
- The southwest downspouts do not appear to be tight to the underground drains which may allow moisture to bypass the drain and collect at the foundation walls. Recommend review of the underground drain and the connections to the downspouts.

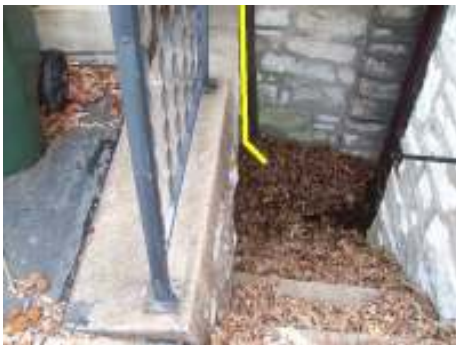
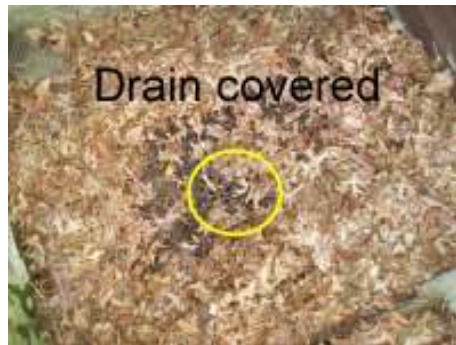
- Underground drains were noted in the yard that appear to be in acceptable condition. However, because it is impossible to see inside them, the seller should provide assurance that the drains are functional, or they should be flushed through to the exit point before the close of escrow. The drains should be kept free of debris to provide adequate flow.
- The downspout from the rear porch should be re routed away from the house to prevent moisture intrusion overtaking the drain at the bottom of the basement stairs and causing moisture intrusion into the basement. The drain at the bottom of the steps needs to be cleared to allow moisture to escape.

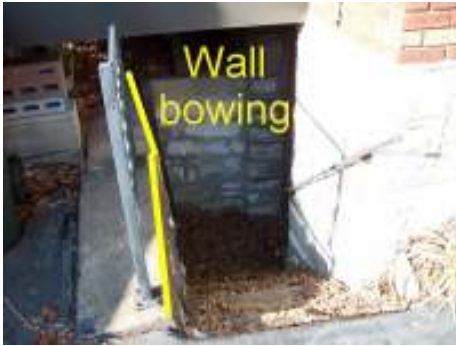
- The retaining wall around the basement stairs is leaning. It is difficult to determine if the movement is ongoing. Recommend monitoring the wall for future movement and consulting a foundation professional if desired.

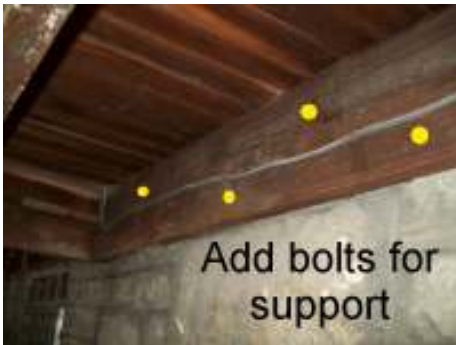
- SAFETY CONCERN - The rear porch ledger board (The board that attaches to the house wall) does not appear to be attached with lag bolts. Lag bolts are recommended to properly support the porch where it attaches to the house and to prevent failure. The lag bolts should be offset and not in a straight line.

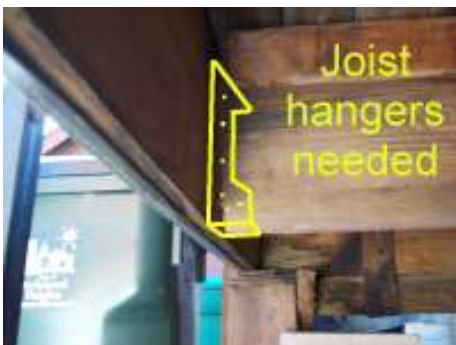
- The deck was constructed without joist hangers to reinforce the connection of the floor joists to the ledger boards. Recommend adding joist hangers for added support.

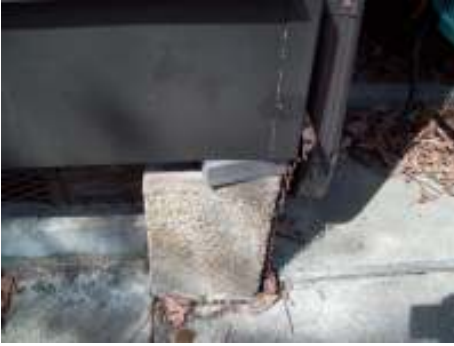
- The floor joists do not have a reinforced connection to the support columns. The floor structure appears to rest on shims placed in between the column without reinforcement. Brackets are recommended for the connections of the floor joists to the support columns.

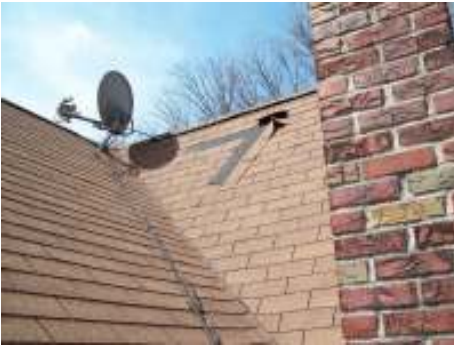
- Due to the slope, the roof was viewed from the gutter line and from the ground.
- A Seller's Disclosure was not available and the age of roof is unknown. The inspector recommends that you request the installation permit from the sellers, which will reveal its exact age and any warranty or guarantee that might be applicable.
- The roof is covered by a 3-tab asphalt shingle, which is typically rated for 15-20 years.
- The roof has a single layer.
- Loose shingles were noted at the north section of the roof. The shingles need to be replaced.

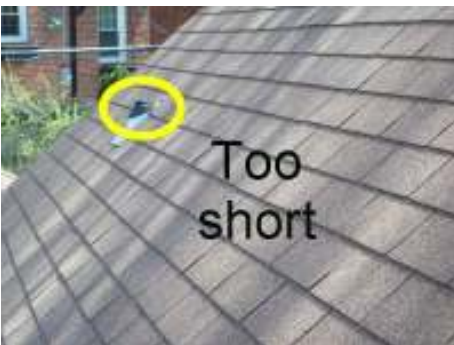
- The northeast plumbing vent is too short. The vent should extend a minimum of 6 inches to avoid being overtaken by snow.

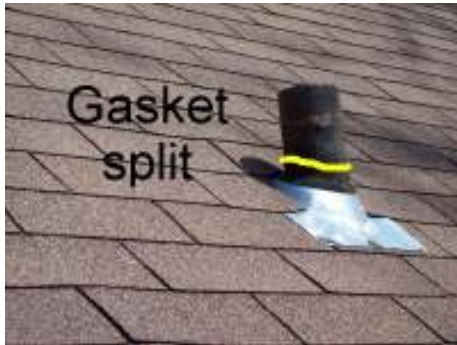
- The southwest plumbing vent's neoprene gasket is split, which will allow moisture intrusion into the attic. Repair is needed.

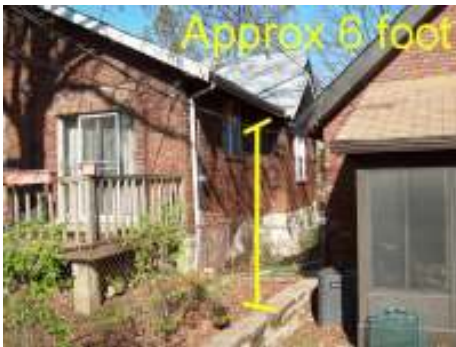
- The home is equipped with a 200A electrical service.
- The electrical service drop wires are too low over the driveway and need to be raised for safety. The wires measure approximately 6 feet from the top of the retaining wall. The wires should be a minimum of 10' above a walkway. Further review is recommended from the utility.

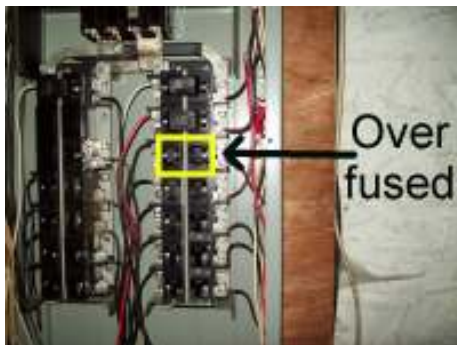
- The main electrical panel uses Pushmatic circuit breakers. The Pushmatic does not use a magnetic trip mechanism; they are only a thermal breaker. Current technology uses both magnetic and thermal tripping mechanisms, which increase safety and the likelihood that they will function properly. It has been reported over time, the Pushmatic breakers become very stiff and difficult to operate or reset. The internal alert mechanism that indicates the position of the circuit breaker as "on", "Tripped", "off" fails inside of individual circuit breakers, which may be confusing for a homeowner to know the position of the breaker. This could be viewed as a significant potential shock hazard. Recommend review by a licensed electrician.

- There are no visible deficiencies with the circuit breakers in the main electrical panel. The circuit breakers were not removed for inspection.
- Over fusing was noted on the left side of the panel with a #15 wire on a 20A breaker. Over fusing is a condition where the size of the breaker is too large for the wire size and can be a potential fire hazard. Repair is needed by a licensed electrician.

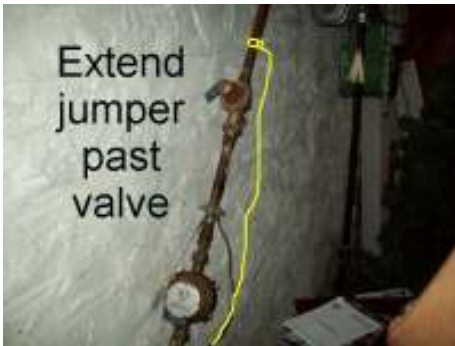
- UPGRADE SUGGESTION - The jumper wire should be extended to bypass the Pressure Reducing Valve on the main water line.

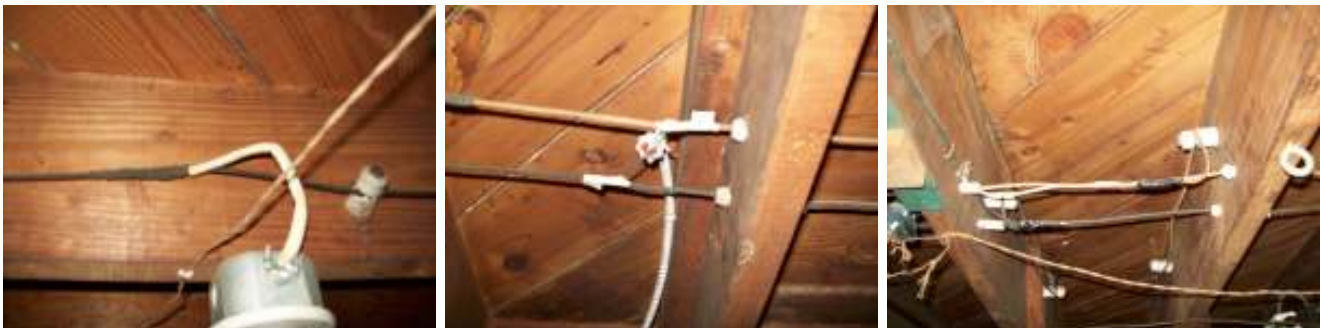
- The electrical receptacles are both 2 and 3 prong.
- The receptacles were tested with a basic three-prong circuit tester.
- Not all electrical receptacles and switches were tested.
- Active Knob and tube wiring is present in the basement. The knob and tube represents approximately 40 % of the visible wiring.
- There are several open splices made to the knob and tube wiring. Any alterations made to the knob and tube should be enclosed inside an electrical junction box. Repair is needed.

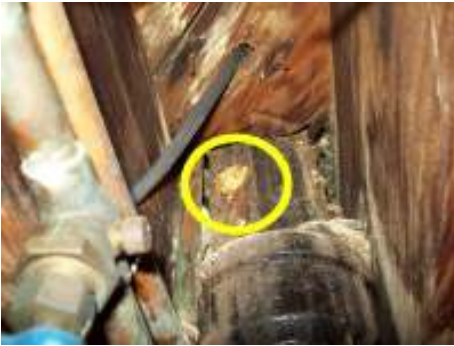
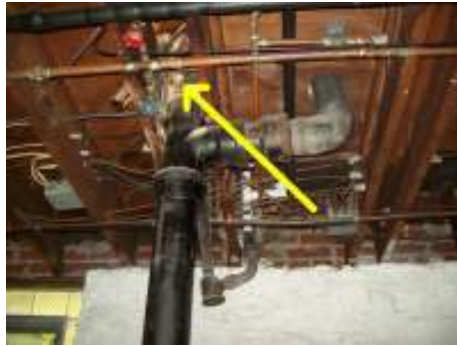
- The waste stacks are made of lead cast iron and PVC. The cast iron pipe typically has a 50 year expected life.
- Rust nodules and evidence of intermittent leaking were noted at the main waste stack in the basement. No active leakage was observed at the time of the inspection. The cast iron pipes are approaching their expected life span and this section needs further review by a licensed plumber to determine if repairs or replacement are needed.

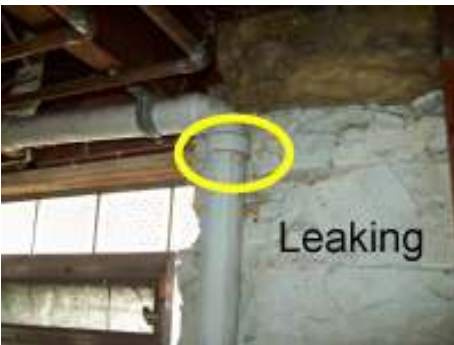
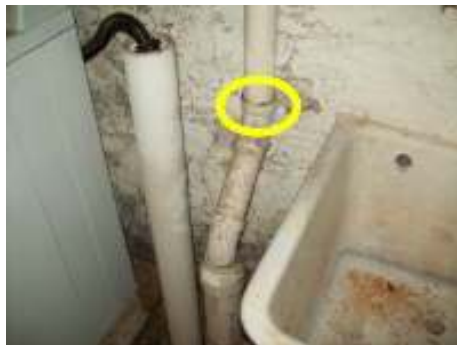
- The kitchen drain waste stack is leaking at the connections and needs to be repaired.

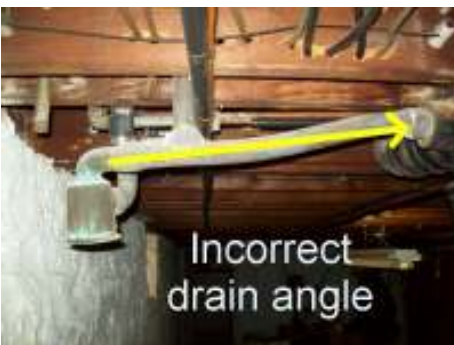
- The drain for the bathtub is sloped incorrectly and runs uphill. This may not allow the tub to drain properly. Repair is needed.

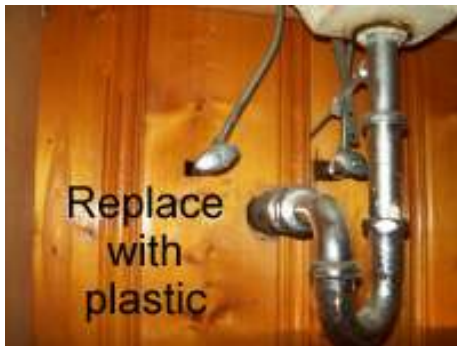
- The second floor half bathroom faucet, sink, and counter are in serviceable condition and functional.
- **UPGRADE SUGGESTION** – The inspector recommends replacing the drain trap with plastic or PVC pipe.

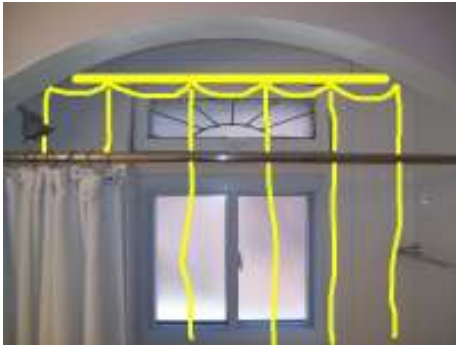
- The hallway bathroom commode is functional and tight to the floor.
- The tub/shower faucet mechanism and the shower walls are in serviceable condition.
- **MAINTENANCE SUGGESTION – Add a second clear shower curtain to cover the window wall and avoid moisture collecting at the window sill.**

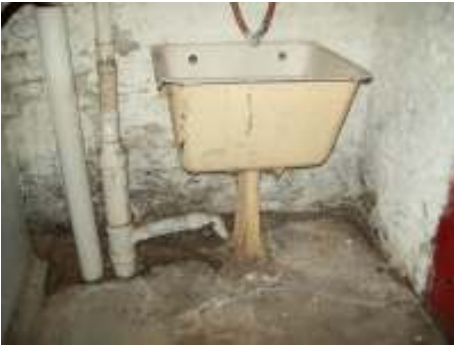
- The laundry area is in serviceable condition. The appliances are in place.
- The appliances were not tested.
- A 240V electrical outlet provides power for the electric dryer.
- The washer drain stack is in serviceable condition.
- The water faucets appeared to be in serviceable condition with no leaks noted at the time of the inspection.
- The laundry tub was probably not permitted or approved by the local authority and is considered to be a temporary arrangement. You may have to remove the tub to be in compliance with current standards.

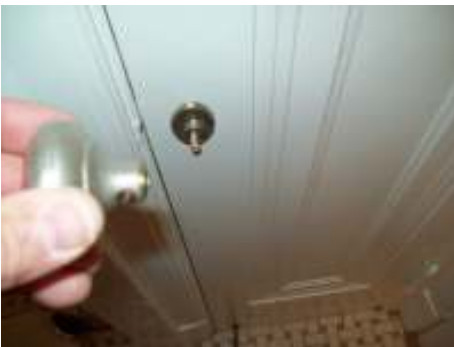
- The entrance door and locking mechanism are in serviceable condition.
- The rear entrance door and locking mechanism are in serviceable condition.
- The hallway bathroom linen closet door lock was loose and needs repair.

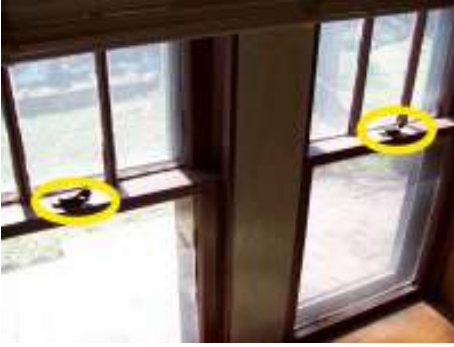
- All windows tested were functional. The screens are not part of the inspection.
- The second floor southeast windows are locked with a nail. Part of the locking hardware has been removed.

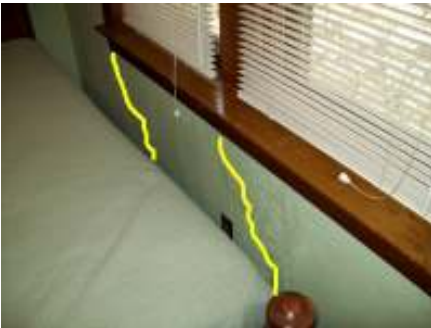
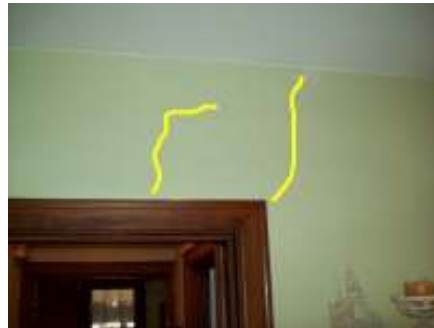
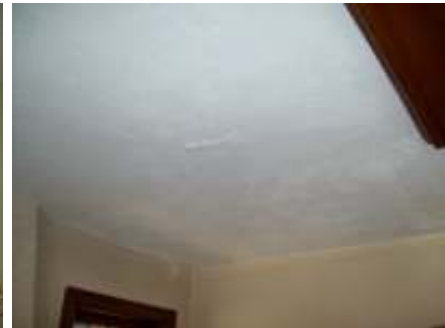
- There are numerous cracks and patched cracks in the plaster walls which are common. The patched cracks do not appear to be the work of a professional.

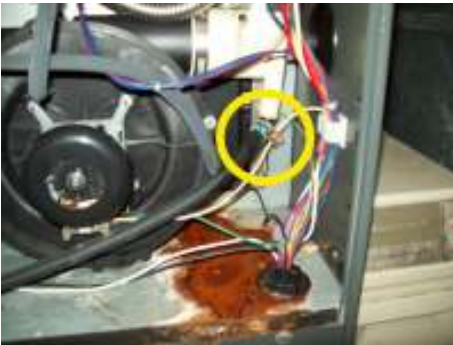
- The condensate line for the flue pipe is leaking and needs to be repaired.

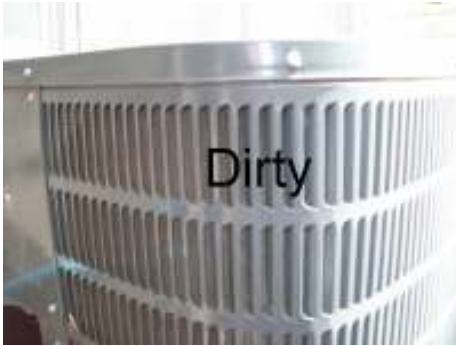
- **MAINTENANCE TIP:** The condenser fins are dirty and need to be cleaned. The build up could affect the efficiency of the cooling system.

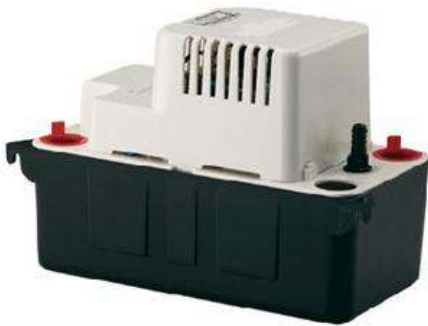
- **UPGRADE SUGGESTION -** The drain lines for the condensate and the humidifier do not have access to a floor drain in the utility room. The inspector recommends a condensate pump to direct the water to the exterior. See below:

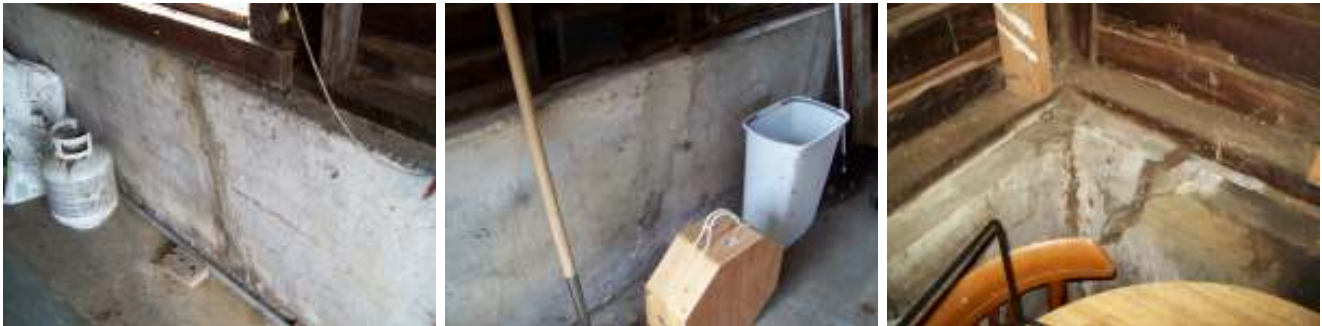
- Cracks and movement were noted in the walls of the garage. The cracks have been patched and the patch material has re cracked.

- Recommend further review of the garage structure by a qualified structural contractor.

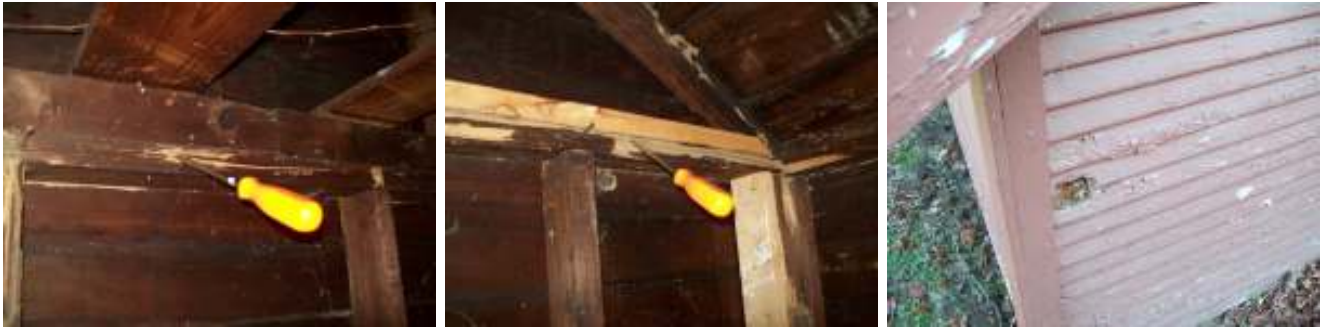
- There is damage from wood destroying insects on the rear wall framing of the garage. A portion of the damage has been reinforced.

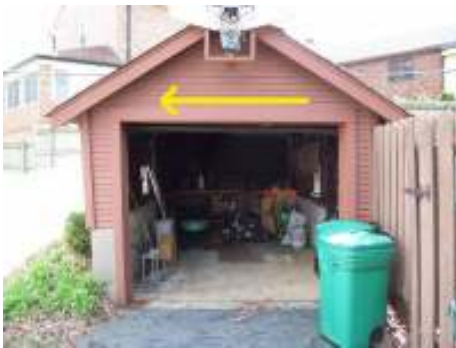
- The garage appears to be leaning to the northeast.

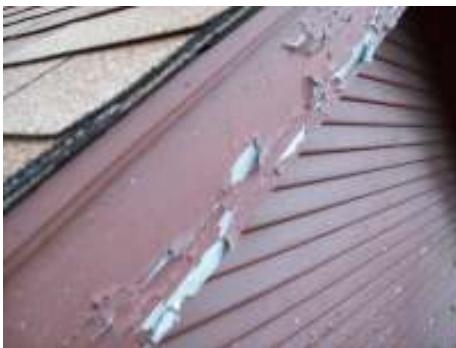
- A gutters is not installed on the northeast roof.
- There is peeling paint on the rear exterior. The exterior needs to be scraped before recoating.
