Inspections Complete, LLC

Confidential Home Inspection Report for:

123 Example Lane, St. Louis MO 12345

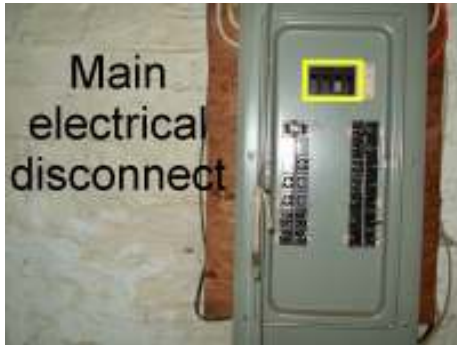
Electrical service panel:

- The electrical service disconnect breaker is located at the top of the service panel in the basement.

- The main electrical panel uses Pushmatic circuit breakers. The Pushmatic does not use a magnetic trip mechanism; they are only a thermal breaker. Current technology uses both magnetic and thermal tripping mechanisms, which increase safety and the likelihood that they will function properly. It has been reported over time, the Pushmatic breakers become very stiff and difficult to operate or reset. The internal alert mechanism that indicates the position of the circuit breaker as "on", "Tripped", "off" fails inside of individual circuit breakers, which may be confusing for a homeowner to know the position of the breaker. This could be viewed as a significant potential shock hazard. Recommend review by a licensed electrician.

- There are no visible deficiencies with the circuit breakers in the main electrical panel. The circuit breakers were not removed for inspection.
- Over fusing was noted on the left side of the panel with a #15 wire on a 20A breaker. Over fusing is a condition where the size of the breaker is too large for the wire size and can be a potential fire hazard. Repair is needed by a licensed electrician.

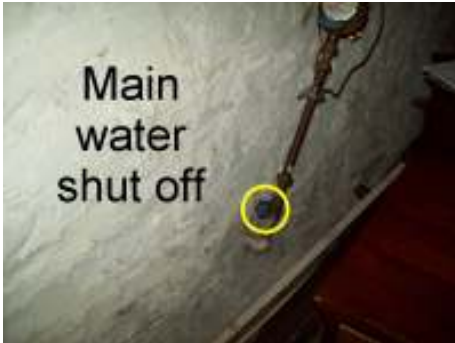
Main Water Supply:

- The main water shut off is located in the basement, northwest wall. The main line is galvanized. The shut off valve was not tested.

- The visible portions of the water pipes are copper and galvanized.
- The water pressure appears to be within an acceptable range but was not tested with a gauge.
- No active leaks were noted at the time of the inspection.
- The handle on the southeast hose faucet was broken. The faucet appeared to be dripping. The hose was attached and was removed.

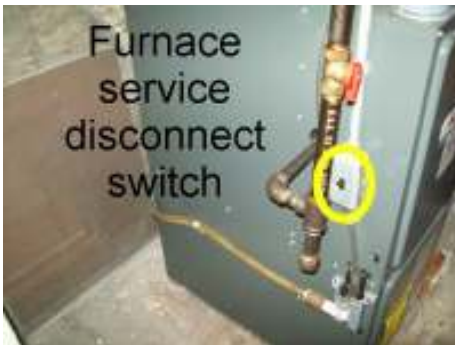
- Amana manufactured the furnace in approximately 2005. The furnace appeared to be functioning properly.
- The electronic filter was in place but was not tested.
- Return air vents are not present at the second floor. Air needs to be allowed past the door at the bottom of the stairs to reach the return vent at the main floor.
- The disconnect switch is located on the side of the furnace cabinet.

- The condensate line for the flue pipe is leaking and needs to be repaired.
